AD-8000 Power Supply Unit

After over 6 years of servicing the AD-8000, the Apogee Service Department has acquired significant insight into troubleshooting the AD-8000 Power Supply Unit. In order to expedite repairs in the field, we offer the following guidelines, including schematics and board layout documents.

Updating to Revision E4

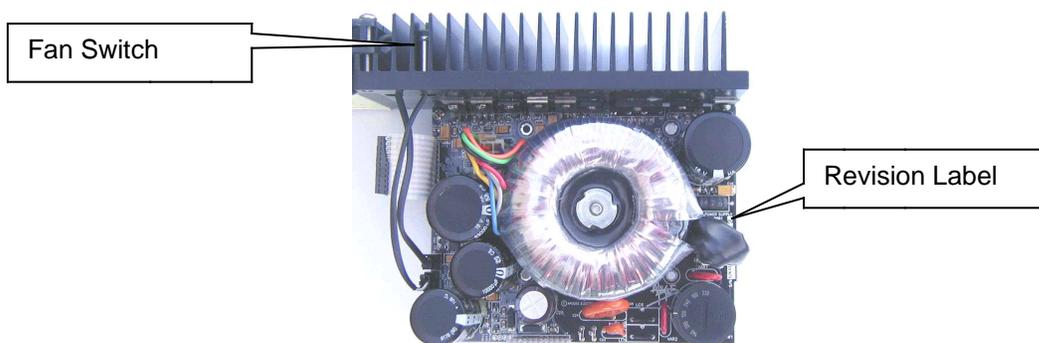
All AD-8000s must be equipped with a revision **E4** PSU; the revision label may be found at the location indicated below. Revision E PSUs and above should be updated to rev. E4 as described further in this document. Revision D PSUs and lower must be replaced.

Switching off the fan is strongly discouraged, and should only be done when the AD-8000 is free-standing outside a rack. The location of the fan switch is indicated in the photo above.

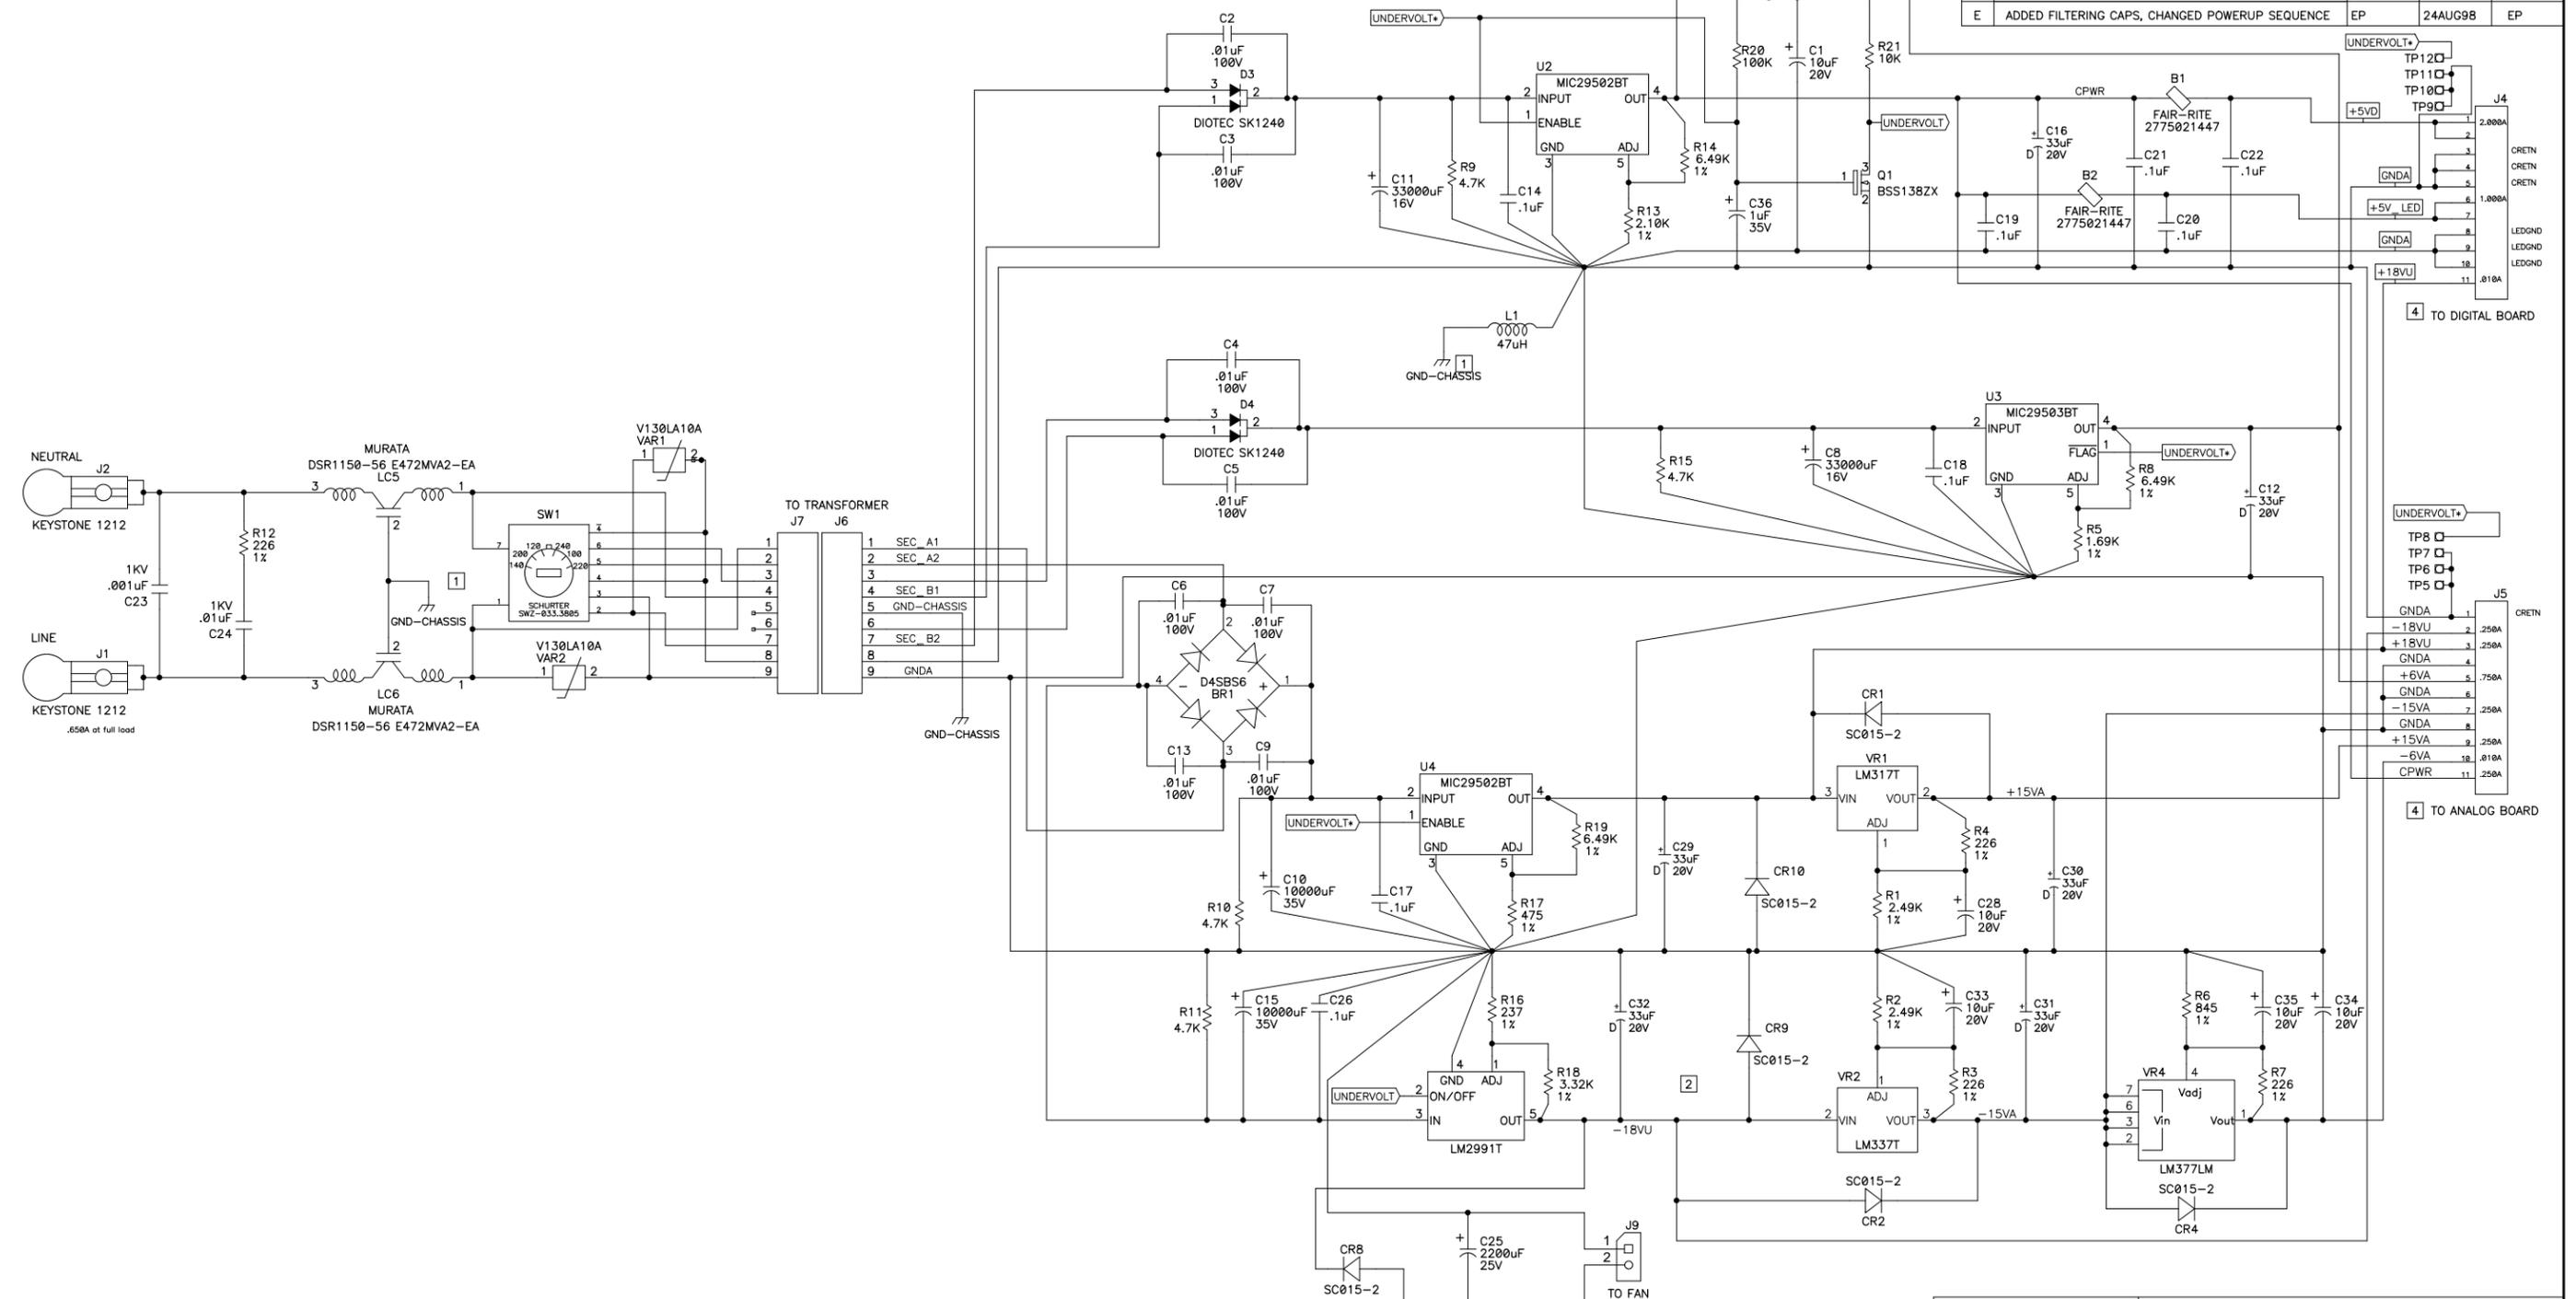
| Ed Pendyk | 3-11-98 | AD-8000 POWER SUPPLY BOARD | |

- 1) Of course, all troubleshooting should begin with a careful inspection of the board.
- 2) All regulators are enabled by the +6 regulator (U3); thus, if the +6 circuitry fails, all power rails will be down.
- 3) In our experience, the regulators fail rather infrequently; if a regulator appears to pass a DC voltage without regulating it, carefully inspect the passive components around it.
- 4) If the +5 digital board voltage is lower than 5.0 volts DC when under load, see the **Updating to E4** section below.

All AD-8000 PSUs should be updated to revision E4; this may be accomplished by performing the following modifications. See the schematic and board layout diagrams at the end of this document to locate the components to be changed.

- 1) Change R14 to 6.81kOhms 1/4watt 1% resistor
- 2) Change R8 to 6.04kOhms 1/4watt 1% resistor
- 3) Change R6 to 768 Ohms 1/4watt 1% resistor
